## Le niveau d'eau 2019: Une comparaison entre le Grand Lac Rond (Lac Roddick) et Lac 31 Milles

Michael Lukyniuk  
Le 29 septembre 2019

## Water levels 2019:

### A comparison between Grand Lac Rond (Lac Roddick) and Lac 31 Milles

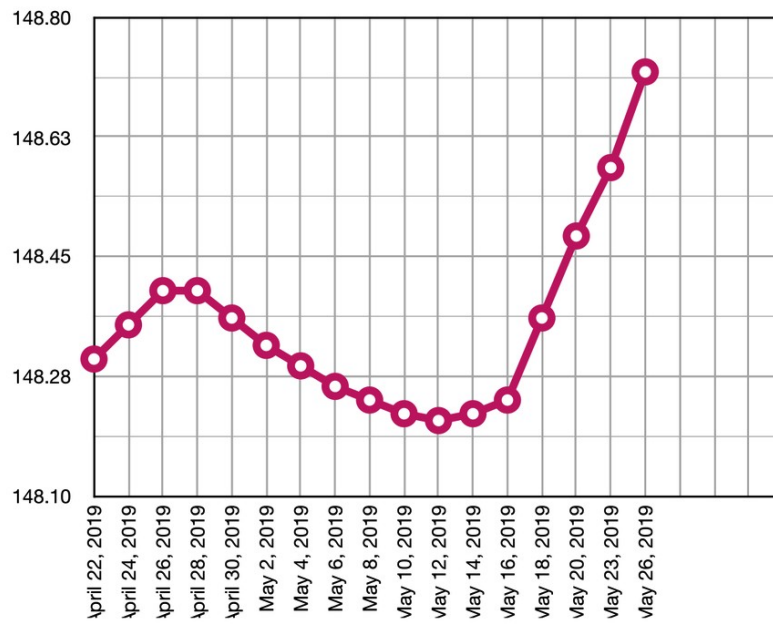
Here are two charts which illustrate the changes on Grand Lac Rond and Lac 31 Milles from April 22 to May 26:

would be too low. In spring, Grand Lac Rond benefits from the retention of water by the dam, otherwise the lake would be flooded since the thawing snow and spring showers also take place at the same time. Up to May 4, 2019 everything was functioning fine – the water level of Grand Lac Rond was lowering slowly and the retention of water was taking place at Lac 31 Milles. (The water level at Lac 31 Milles was at 162.60 m – essentially 50 cm (19 inches) higher than the normal level in summer.) Unfortunately from May 4 to 23 the dam evacuated large quantities of water from Lac 31 Milles lowering its water level by 20 cm (8 inches). This effect was catastrophic for Grand Lac Rond – its water level **rose by 59 cm (23 inches)** at a level which was 1.7 m (67 inches) higher than the normal level in summer. The lake experienced its heaviest flooding since 1974. Of course, high precipitation and the elevated level of the Gatineau River also contributed to the disaster. But the discharge from the dam was the principle reason for the rising floodwaters. Since May 23, the water level of Lac 31 Milles has stayed stable (at 162.38 m) and, finally, on May 31 the water level of Grand Lac Rond began to descend (but it is still very high today at 148.34 m).

To put the situation in context, at the end of May Grand Lac Rond was still flooded at **1.24 m (48 inches) higher than the normal level in summer**; Lac 31 Milles was **28 cm (11 inches) higher than the normal level in summer**. With the dam continuing to retain water from Lac 31 Milles, there is hope that the water level on Grand Lac Rond can descend to acceptable environmental levels.
